ADVANCE REPORT
on the
SEDIMENTATION SURVEY OF LAKE BRACKEN
GALESBURG, ILLINOIS

July 9 - August 15, 1936

Sedimentation Studies
Division of Research
SCS-SS-14
May, 1937

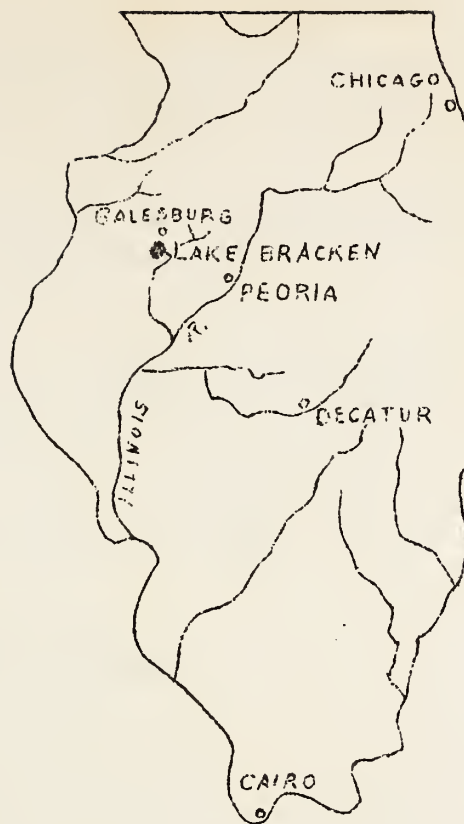
Fig.1- Location and general relations of Lake Bracken and its watershed.

Location (fig. 1):

watershed, near the main stream courses, erosion of the channel type becomes much more severe, and some dangerous gullies are developing, as in sections 2, 3, 10, 11, and 12. (fig. 1). Wherever the original dense forest and grass cover has been preserved along the valley slopes, erosion has not become destructive, but in some areas, especially in sections 10 and 12 where much of the oak forest has been cut for lumber, this protection has not been maintained. Soil conservation practices in general have not come into use in this watershed.

The relatively large quantity of sediment in the north arm indicates that erosion in gullies and on slopes in sections 2 and 3 (fig. 1) contribute most of the silt now being deposited in Lake Bracken. The headwaters of this arm tap areas where removal of natural vegetation and cultivation of crops on sloping land have induced rapid erosion.

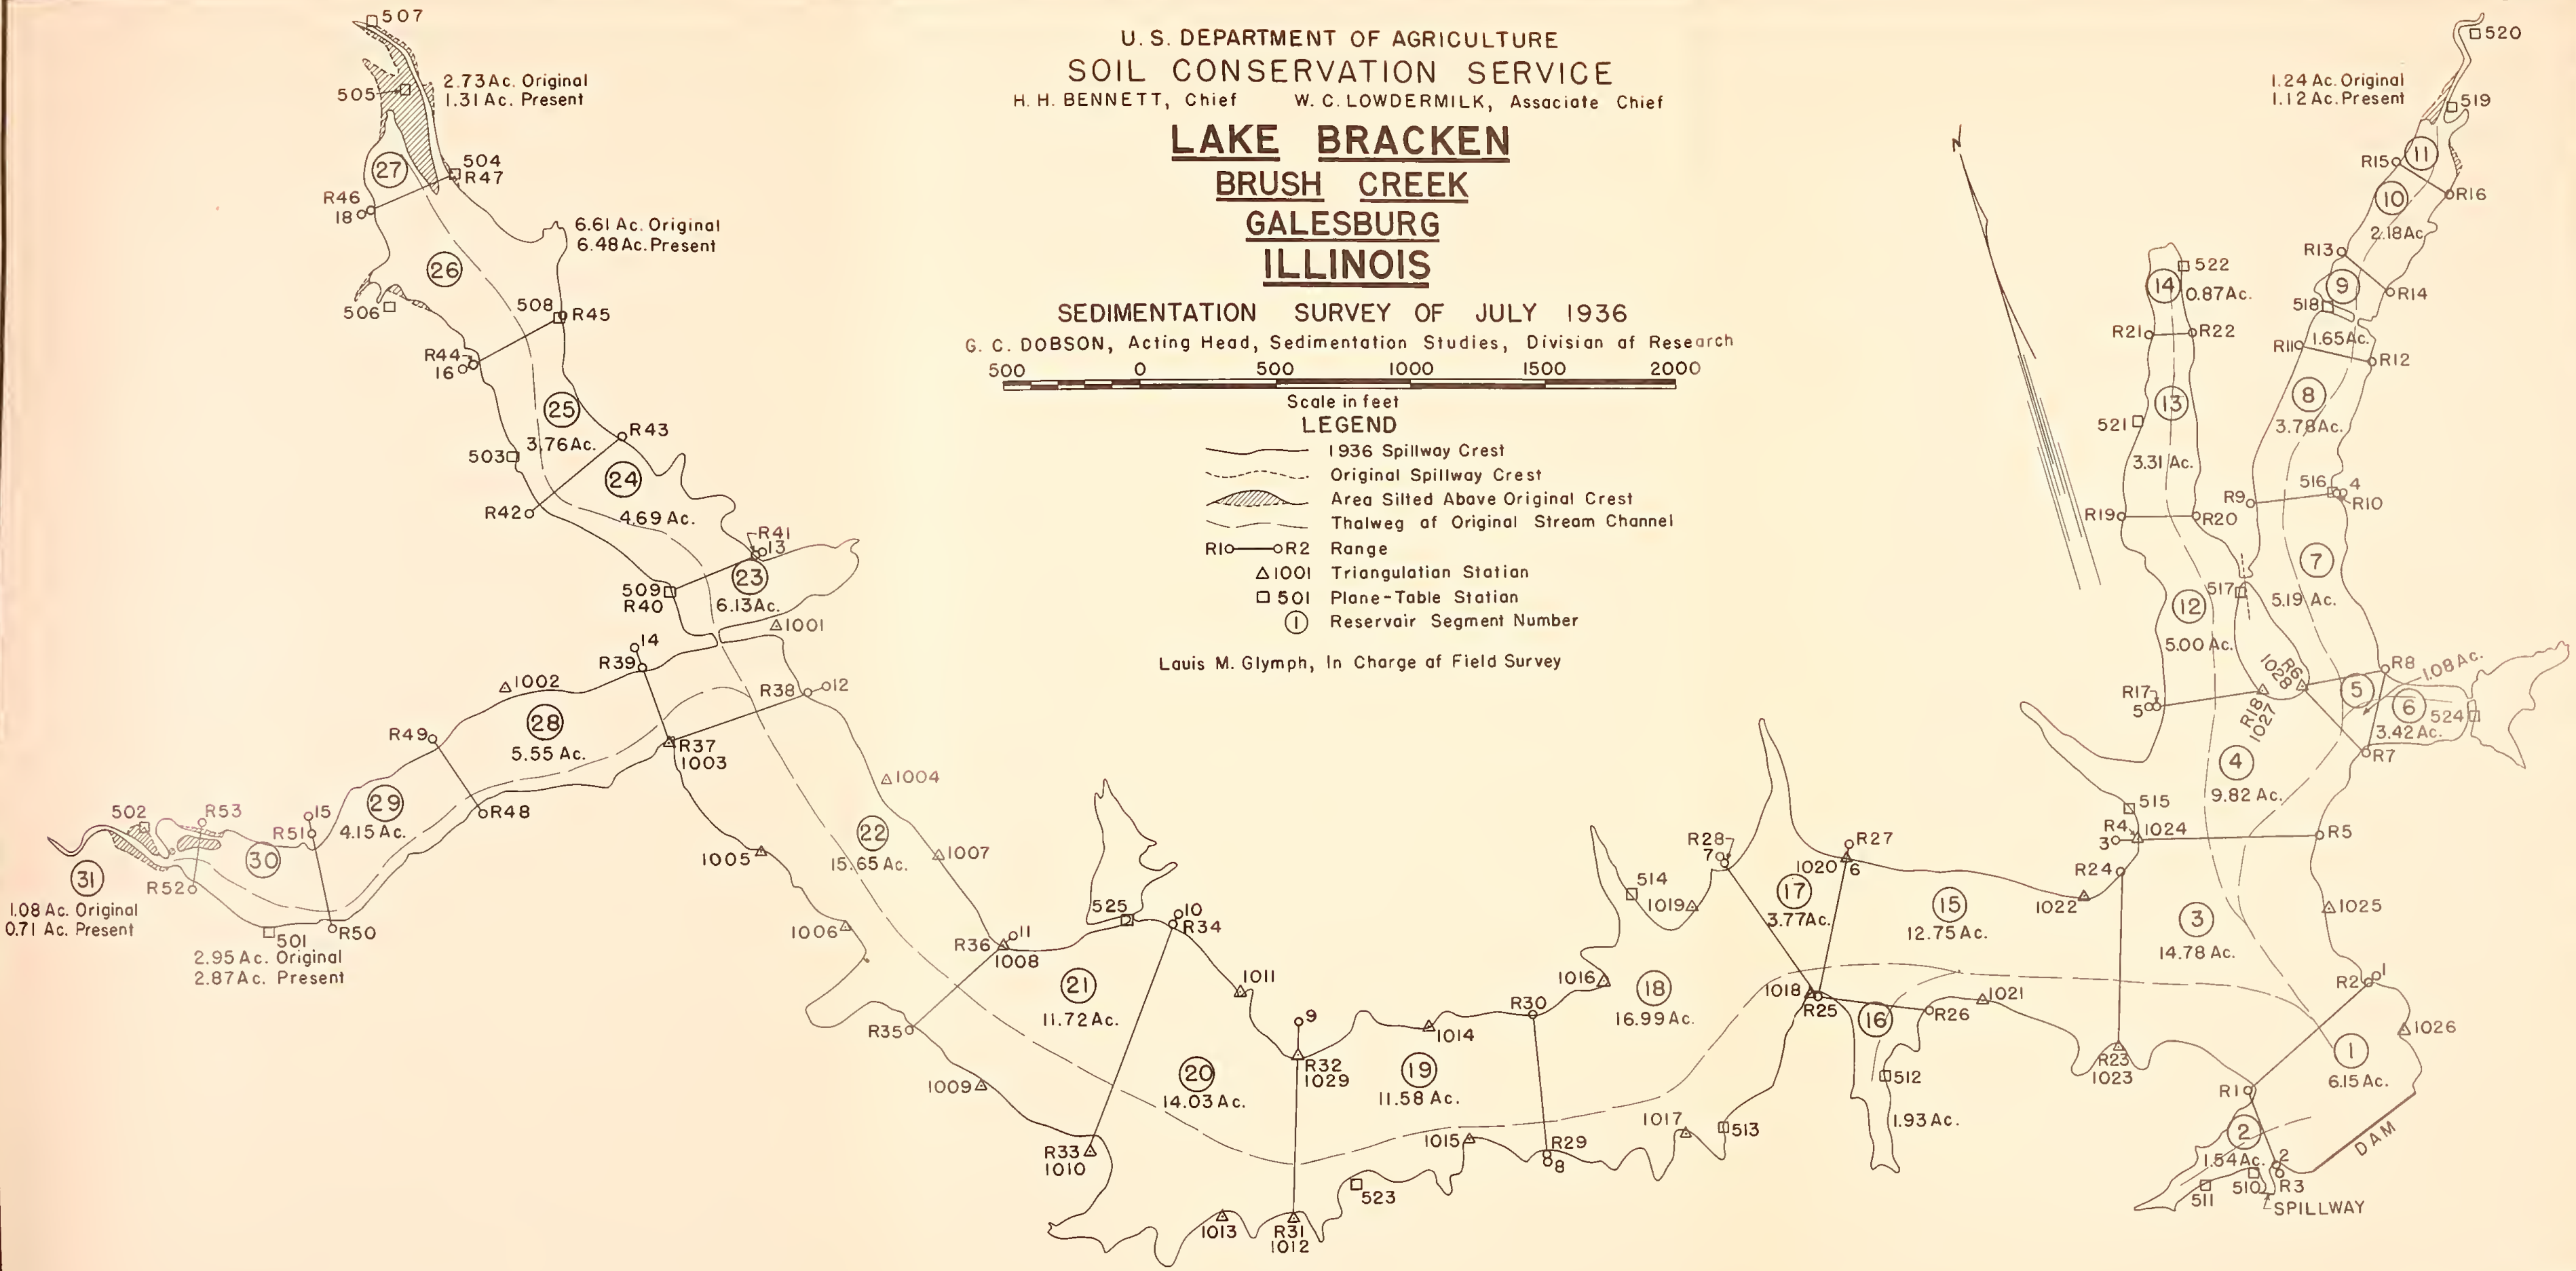
LAKE BRACKEN
BRUSH CREEK
GALESBURG
ILLINOIS

General character of reservoir basin: Lake Bracken is long, narrow, and sinuous in general outline, but its shore line is made very irregular by several tributary arms (fig. 3, following page 10). The main lake is nearly 2 miles long and is 500 to 600 feet wide through most of its length, tapering gradually toward the head of backwater.

Distribution of sediment: The greater part of the submerged flood plain has received a relatively thin deposit of silt, and the accumulation in the channel in some places is only slightly thicker. In the lower 0.8 mile of the main basin, below range R31-R32, (fig. 3, following page 10) about 1 foot of silt covers the flood plain whereas the common thickness in the channel is 2 feet. Between range R31-R32 and the upper forks of the reservoir the silt thickness continues at 1 foot on the flood plain but ranges between 3 and 4 feet in the channel. On Brush Creek above the forks there is no distinct channel, and the silt

thickness increases more or less gradually from 1 foot on range R37-R39 to 2 feet on range R50-R51, and then increases suddenly to a maximum depth of 6.5 feet on range R52-R53, where a small delta has developed in the head of the arm.

The north arm, including segments 23 to 27, has received the heaviest accumulation in the lake. The deposit nearly everywhere exceeds 3 feet in thickness and on range R44-R45 attains a maximum depth of 6.6 feet. An extensive exposed delta at the head of this arm has advanced the shore line in one place about 450 feet downstream and has produced an average shortening of about 300 feet. Altogether, about one-third of the storage capacity of the north arm has been destroyed by sedimentation.

SEDIMENTATION SURVEY OF JULY 1936

Primary triangulation involved the establishment of a 1,000-foot base line measured by steel tape along the graveled road adjacent to segments 23 and 28 (fig. 3, following page 10). From this base 29 triangulation stations were established as a system of control for all mapping. The lack of a suitable original map necessitated complete mapping of the shore line, which was done with plane table and telescopic alidade on a scale of 200 feet to the inch. Original and present storage capacities and silt volumes were determined by the range method.^{3/} Thirty ranges were established, sounded, and spudded, and 10.9 miles of shore line was mapped, including both original and present lake margins at the heads of the three tributary arms. Permanent monuments, consisting of iron pipe stamped with the station numbers and set in concrete bases, were used to mark the triangulation stations, range ends, and cut-in stations.

Little erosion by wave and current action has occurred along the shores of Lake Bracken. The slight "notching" along both shores of the main lake has furnished only insignificant amounts of sediment, chiefly pebbles, silt, and fine sand, to the reservoir. The shore zone deposits are definite but narrow, and have accumulated to depths of 2 feet on steeper slopes near shore. The crest level contour crosses the irregular contact between the Pennsylvanian sandstone and the overlying Illinoian till at many places, so that about 40 percent of the shore line is on sandstone and 60 percent is on glacial till. Springs of considerable volume issue from the contact zone and from bedding planes in the sandstone at several places, especially in segments 18, 19, 24, and 25 (fig. 3).
